Monitoring Report Q2 2024

Rosetta and Casuarina Landslip Areas

Prepared for
Glenorchy City Council

Date
26 August 2024

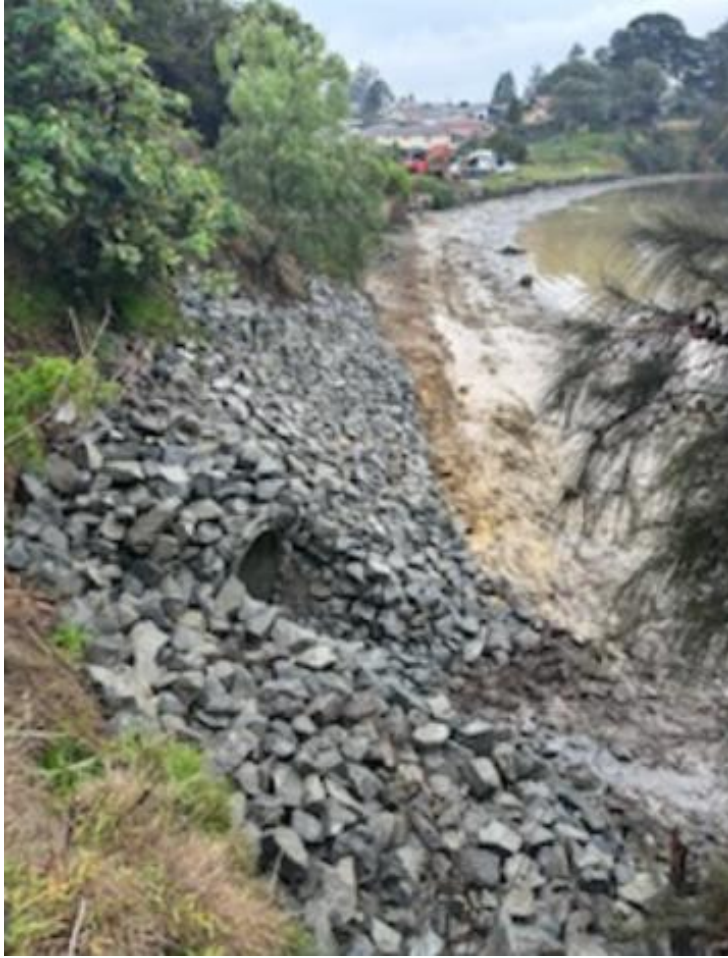
This report also concludes that there are small, localized movements of parts of the Casuarina landslide still occurring, but that mass landslide movements are stable at this time. Previously noted movement at the toe of the landslide appears to have been caused by cracking and leakage of a nearby sewer; it is understood that this has been repaired by TasWater (Figure 2).

Figure 2: Image of repaired stormwater outlet at Casuarina (supplied by GCC; 22/08/24).

The stormwater outfall at Casuarina was observed to be damaged in the previous reporting period. This has now been repaired (Figure 2).

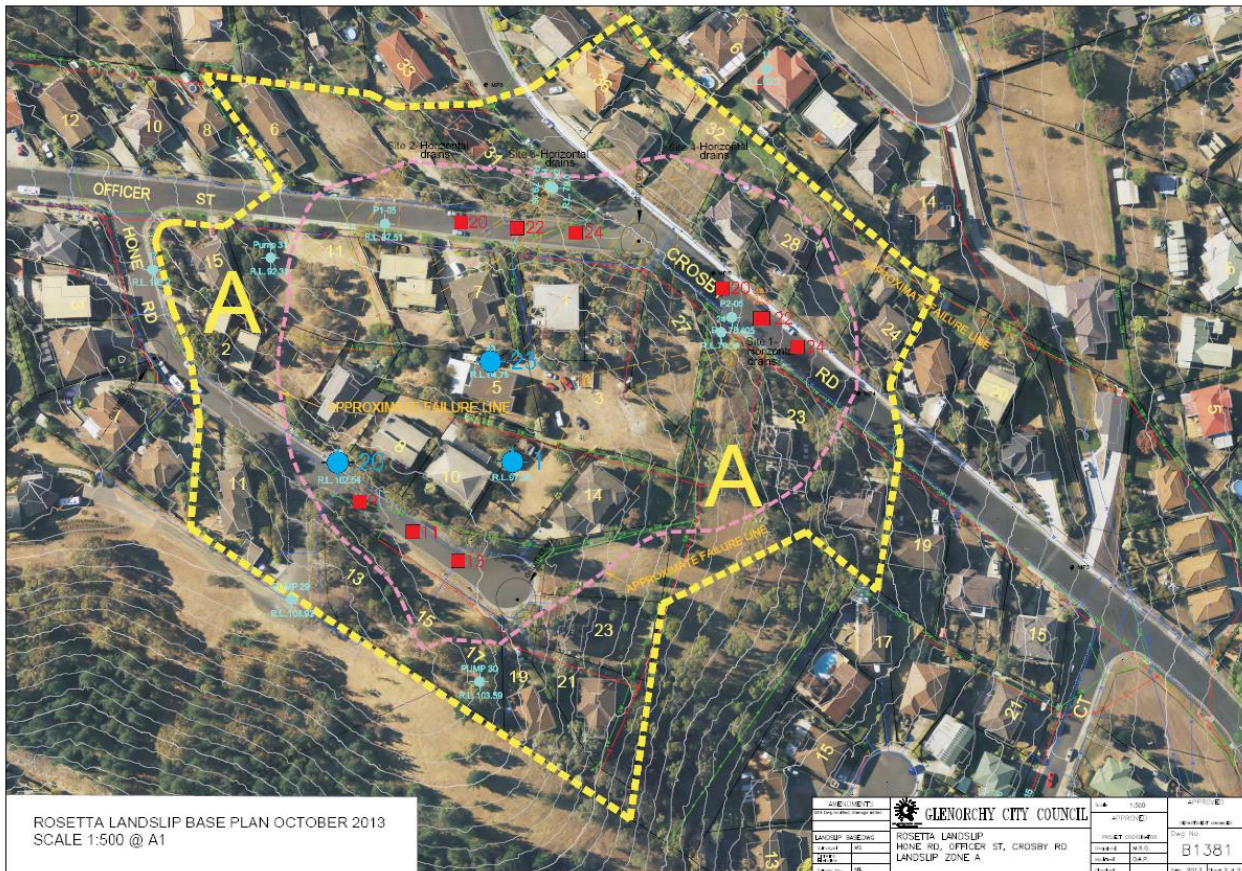
Figure 3: The Rosetta Landslip Area A (yellow outline). Critical survey monitoring points (red) and groundwater monitoring boreholes (blue).

The last survey pickup was conducted by GCC in May 2024. There continues to appear to be a long-term trend of settlement or minor downwards movement in the order of 15-20 mm over the last 10 years in this area, with little in the way of lateral movements. This is consistent with the location of monitoring points within the upper part of the landslide, where downward movements would be anticipated. There is no significant mass-movement of the landslide suggested by data at this time; no significant changes are noted in the current reporting period.

The latest survey was conducted in May 2024. There appears to be a long-term trend of settlement and lateral displacement of between 10 and 15 mm over the last 10 years in this area with survey point 24 showing possibly 15 to 25 mm settlement over the same period, however local movement appears to have stabilised since 2018. No significant mass-movement of the landslide is suggested by data at this time; no significant changes are noted in the current reporting period. Minor downward trend during the current reporting period is considered due to normal seasonal variation and will be monitored over the coming quarter.

The last survey was conducted in February 2024. The three monitoring points appear to have settled by approximately 5-10mm over the last 10 years. There is no significant mass-movement of the landslide suggested at this time, no significant changes are noted in the current reporting period.

Groundwater levels in boreholes 1 and 20 continue to be below levels at which immediate actions are required, which indicates that the pumping and the gravity drainage is effectively maintaining groundwater levels. No landslide movements appear to be associated with a rise in groundwater levels, no significant changes are noted in the current reporting period. Piezometer 23 was unable to be read in the previous reporting period; the current reading appears in line with similar levels accounting for seasonal variation.

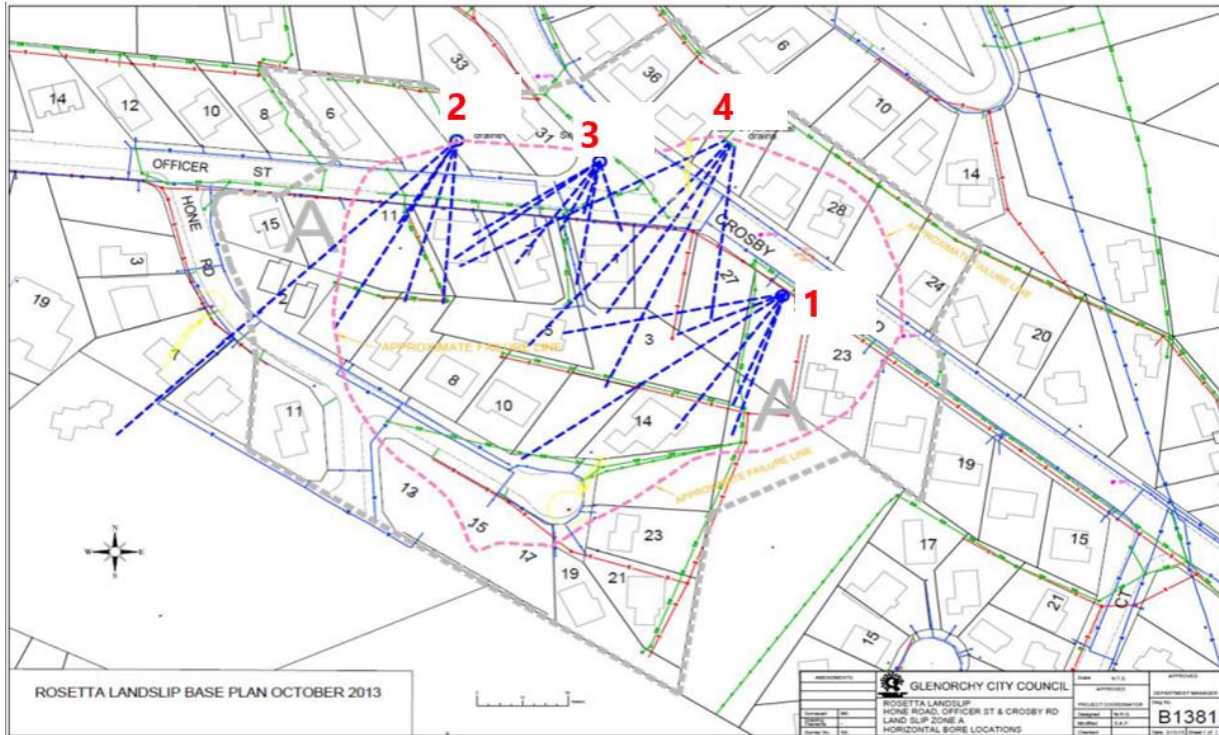
Four arrays of horizontal drains were installed in a fan pattern to drain and stabilize the landslide and have been continuously monitored since 2015, with the outfall connected to the mains stormwater system (Figure 4). Arrays 1, 2 and 3 are all dry with intermittent flows from two pipes in array 4. The most recent flow reading on array 4 has fallen to 0.05 litre/minute since February 2024, following the replacement of pump 31 (Figure 5). Changes to the monitoring regime are not warranted at this stage, no significant changes are noted in the current reporting period.

Figure 4: Installations of horizontal drains within the Rosetta Landslip A Zone

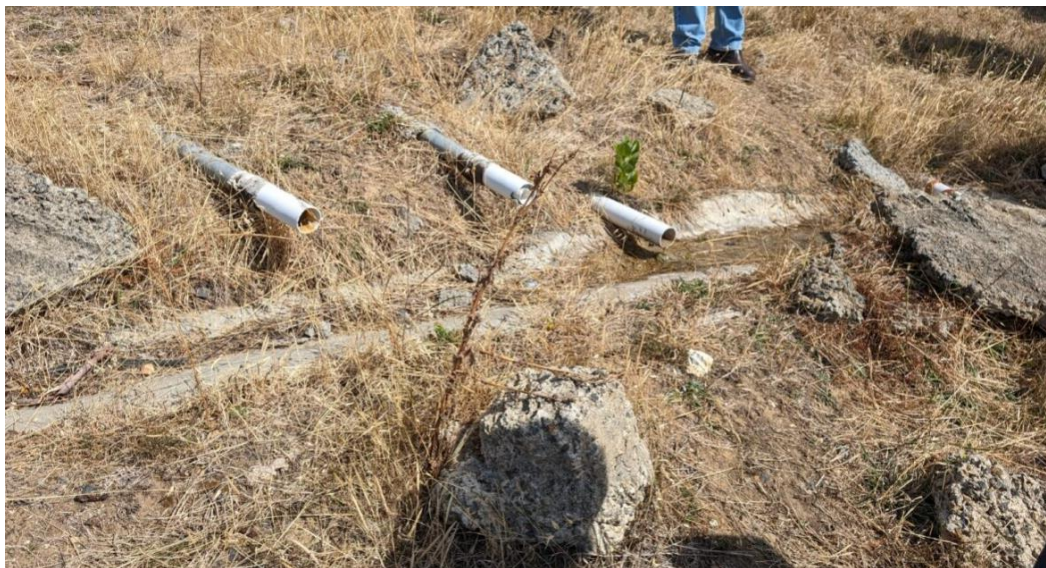
Figure 5: Array 4 outflow point of horizontal drains, minor flow only (image: pitt&sherry, 19th March 2024).

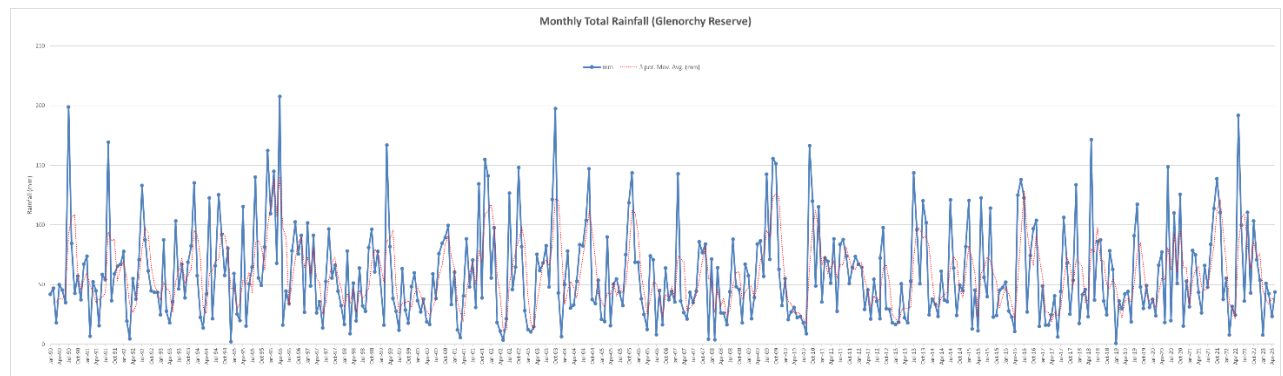
Monthly rainfall is also monitored by GCC directly via a station at Glenorchy Reserve. Apart from expected seasonal variations, no significant trends are observed in local rainfall (Figure 6).

Figure 6: Monthly rainfall monitoring at Glenorchy Reserve

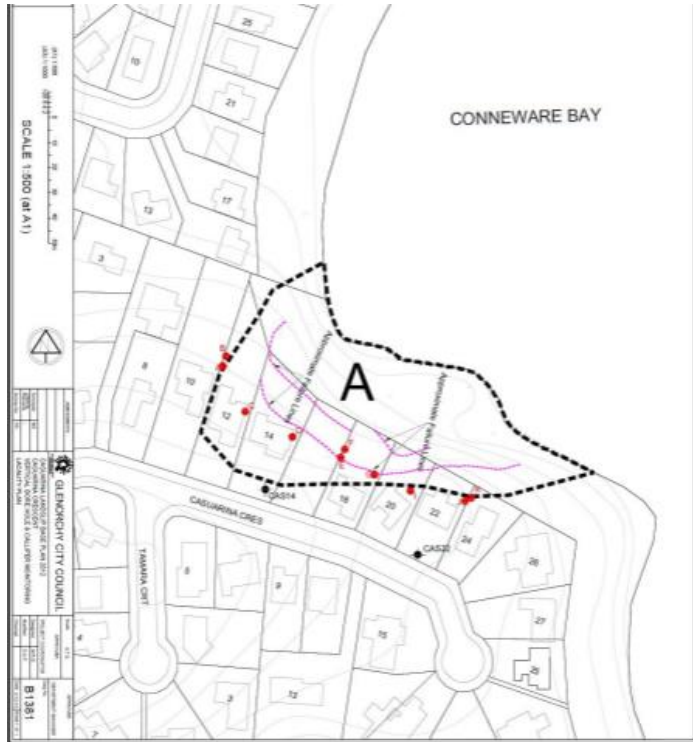
The last survey of Casuarina monitoring points was conducted by GCC in May 2024. There are movements noted in the order of 5mm both laterally and vertically, which most likely reflect seasonal variations in moisture content of clay soils. Movement on the monitoring points shows minimal displacement in the order of 5-10mm over 5 years; with the exception of Control Point 2, which shows a displacement of ~35mm over the same period. Since March 2023, Control Point 2

appears to have stabilised but should remain under close observation, although no significant changes are noted in the current reporting period.

In the current reporting period, Control Point 4 shows signs of minor movement (<10mm) but remains less than 15mm displacement from baseline readings (2015).

Figure 7: The Casuarina Landslip area (A), showing monitoring points (red).
