Monitoring Report Q1 2024

Rosetta and Casuarina Landslip Areas

Prepared for
Glenorchy City Council

Date
2 May 2024

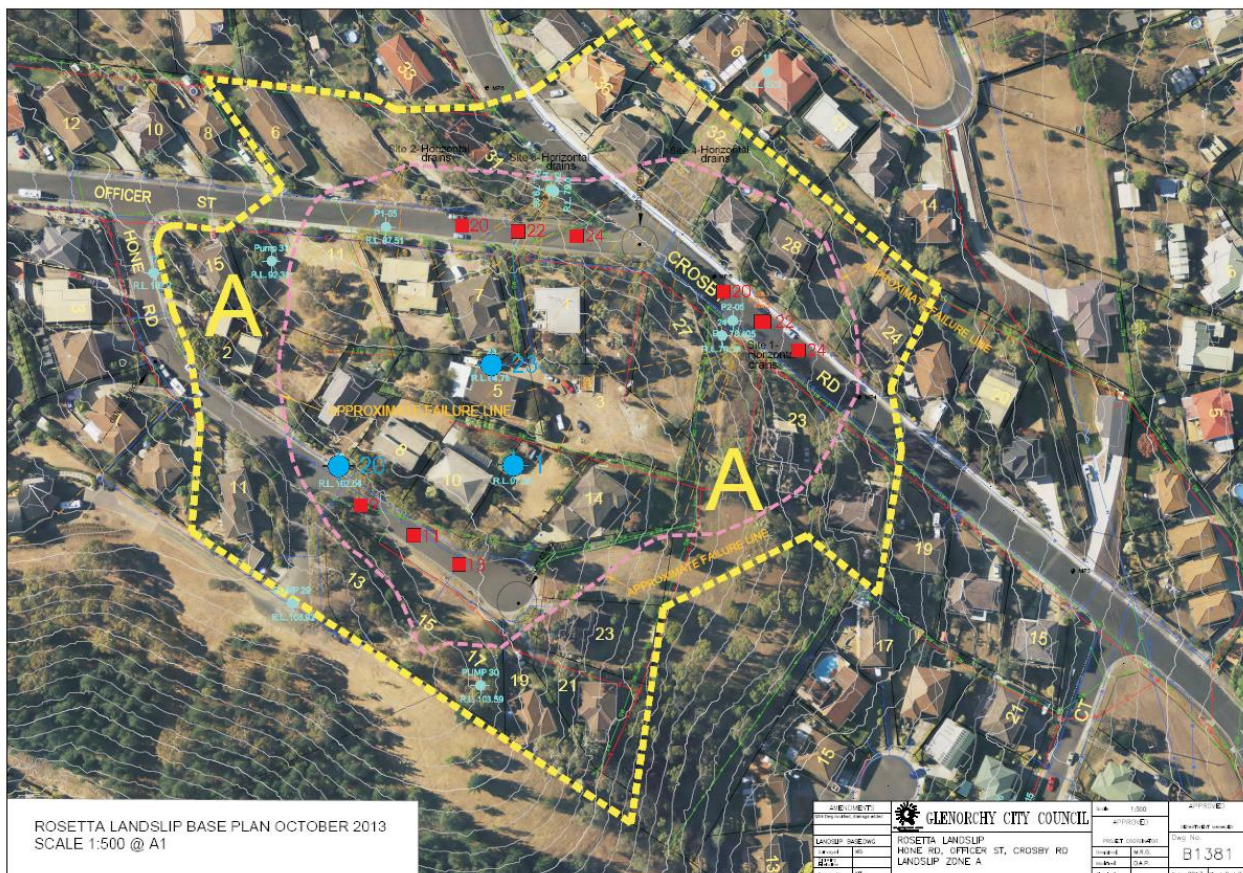
Figure 2: The Rosetta Landslip Area A (yellow outline). Critical survey monitoring points (red) and groundwater monitoring boreholes (blue).

The last survey pickup was conducted by GCC in April 2024. There continues to appear to be a long-term trend of settlement or minor downwards movement of between 15 and 20 mm over the last 10 years in this area, with little in the way of lateral movements. This is consistent with the location of these monitoring points within the upper part of landslide, where downward movements would be anticipated. There is no significant mass-movement of the landslide suggested by data at this time.

The last survey was conducted in March 2024. There appears to be a long-term trend of settlement and lateral displacement of between 10 and 15 mm over the last 10 years in this area with survey point 24 showing possibly 15 to 25 mm settlement over the same period, however local movement appears to have stabilised since 2018. No significant mass-movement of the landslide is suggested by data at this time.

The last survey was conducted in February 2024. The three monitoring points appear to have settled by approximately 5-10mm over the last 10 years. There is no significant mass-movement of the landslide suggested at this time.

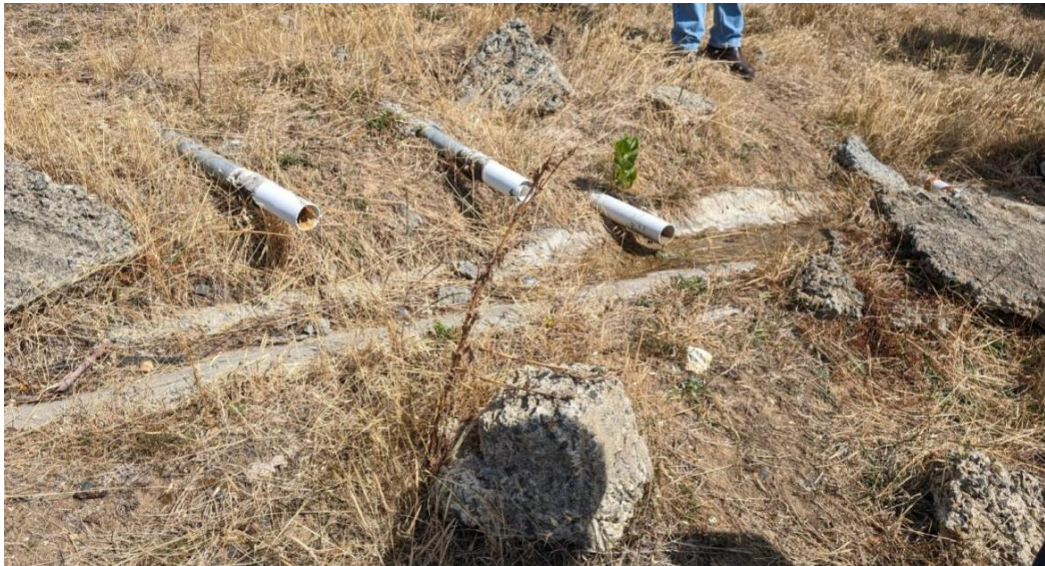
Four arrays of horizontal drains were installed in a fan pattern to drain and stabilize the landslide and have been continuously monitored since 2015, with the outfall connected to the mains stormwater system (Figure 3). Arrays 1, 2 and 3 are all dry with intermittent flows from two pipes in array 4. The most recent flow reading on array 4 has fallen to 0.05litre/minute since February 2024, following the replacement of pump 31 (Figure 4). Changes to the monitoring regime are not warranted at this stage.

Figure 4: Array 4 outflow point of horizontal drains, minor flow only (image: pitt&sherry, 19th March 2024).

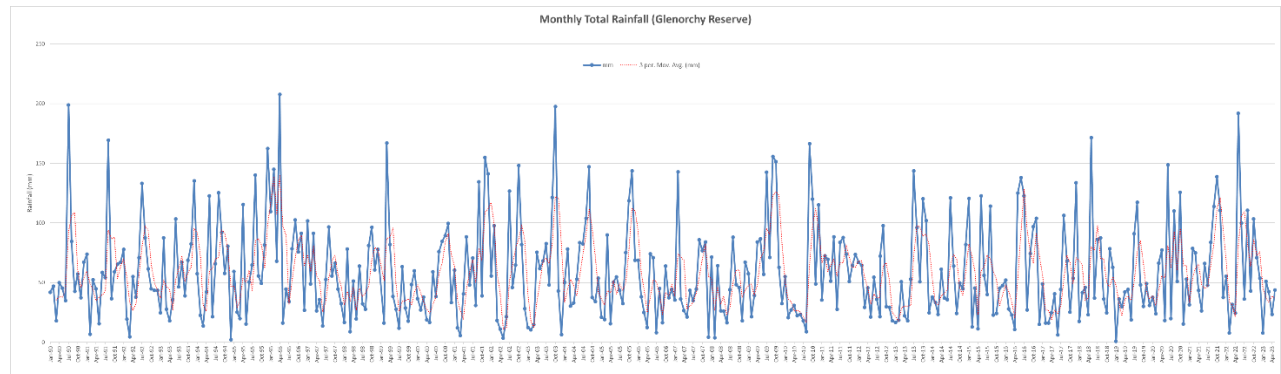
Figure 5: Monthly rainfall monitoring at Glenorchy Reserve

Monthly rainfall is also monitored by GCC directly via a station at Glenorchy Reserve. Apart from expected seasonal variations, no significant trends are observed in local rainfall (Figure 5).

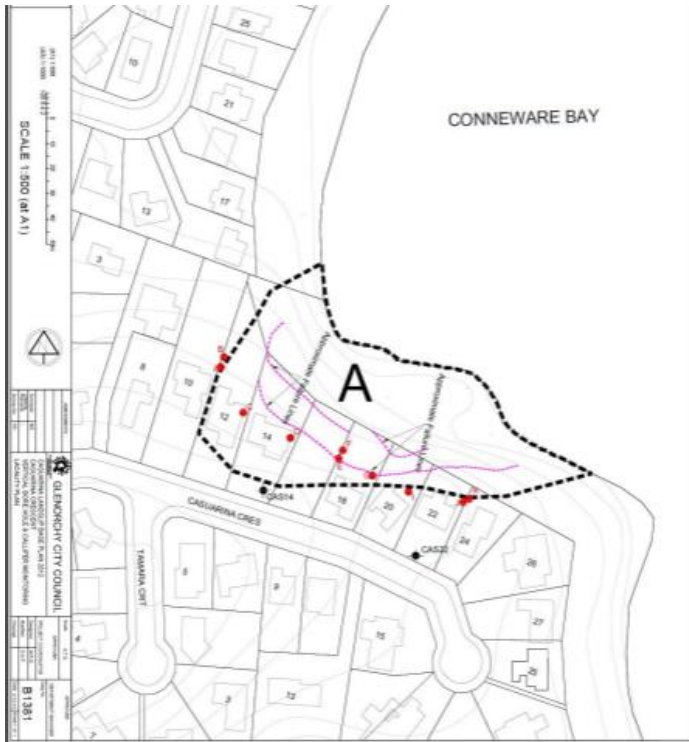
Figure 6: The Casuarina Landslip area (A), showing monitoring points (red).

Casuarina Landslip area is located in the edge of Conneware Bay and is monitored with an array of 10 surface monitoring points along affected properties on Casuarina Crescent (Figure 6). Two piezometers are also installed to 5m and 10m respectively to monitor groundwater levels. Control points have been in place since 2015, and surveys are conducted monthly by GCC.

The last survey of Casuarina monitoring points was conducted by GCC in January 2024. There are movements of several millimetres both laterally and vertically, which probably reflect seasonal variations in moisture content of clay soils. Movement on the monitoring points shows minimal displacement in the order of 5-10mm over 5 years; with the exception of Control Point 2, which shows a displacement of ~35mm over the same period. Since March 2023, Control Point 2 appears to have stabilised but should remain under close observation.

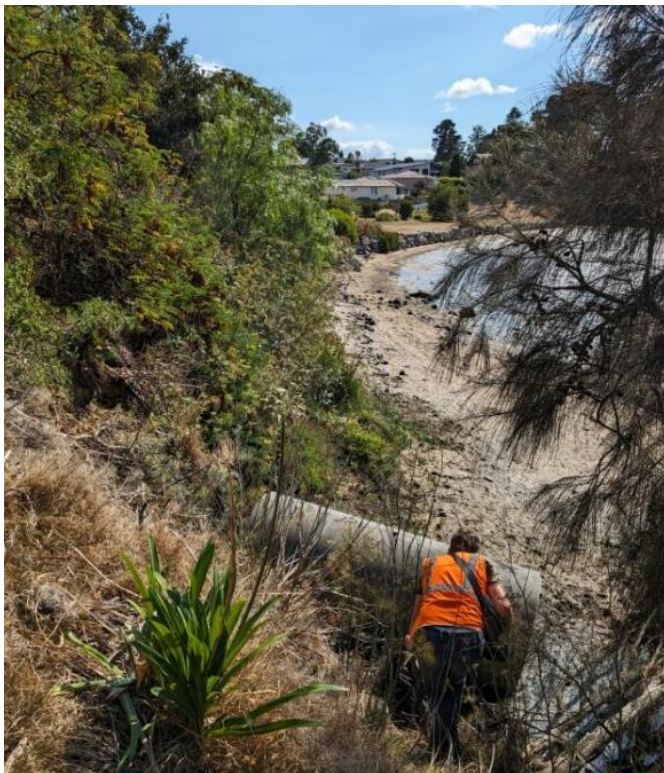
The stormwater outfall at Casuarina was observed to be damaged (Figure 7). It is understood that arrangements are being made to have this repaired.

Figure 7: Disconnected stormwater outfall pipe; Casuarina landslip area

Arrangements are being made to undertake repairs on the damaged stormwater outfall pipe at Casuarina.
